PROPERTY INSPECTION REPORT

Prepared For: Sample Report
(Name of Client)

Concerning: 0000 Main Street, Your Town, TX -
(Address of Inspected Property)

By: Robert V Smith, Jr., #3452 07/07/2006
(Name and License Number of Inspector) (Date)

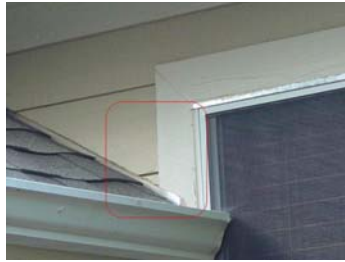
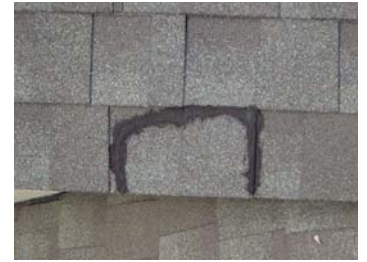
- Roof termination at window above breakfast room is prone to water penetration. Kick out/turn back flashing is not installed which is highly recommended. **See photo 1**
- Exposed nail penetrations in roof need to be sealed with silicone caulk. **See photo 2**
- One shingle over dormer window has been patched. Patch is temporary & should be repaired by a skilled roofer. Client should contact owners for knowledge of prior leak. **See photo 3**

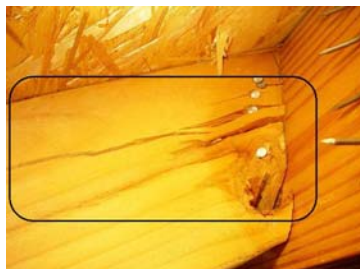
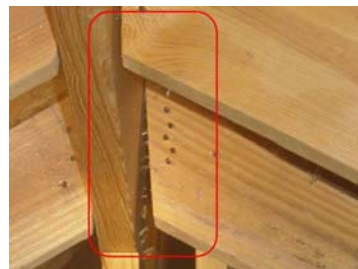
- Anchoring of the pull down stairs to the attic is not the manufacturer's recommended 16d nails or 3" lag bolts (sheet rock screws are not an approved fastener, subject to excessive shear stress). Any other type of anchoring can cause injury. Repair is needed.
- One rafter is cracked over garage & several rafters are separated away from the ridge beam approximately 1/8" or more. Repair is needed by a qualified carpenter to insure that full contact is made between the rafters & the ridge beam.

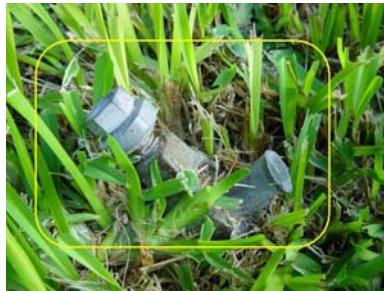
- Ground rod is not driven into the soil the minimum of 8' as per the NEC. The ground clamp was exposed.

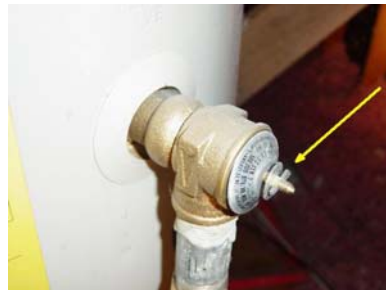
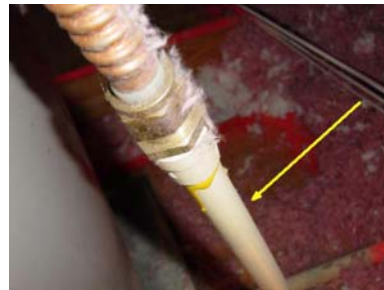
- TPR (temperature & pressure relief) valve trip arm is broken off, TPR should be replaced.
- CPVC pipe is installed on the TPR drain line & routed to the outside. CPVC does not meeting the temperature & pressure standards set by the manufacturer. (The TPR valve is rated for **210 degrees & 180 psi**. The CPVC is rated for **180 degrees & 100 psi**). CPVC should be replaced with an approved material.
